MACH 6 ELECTROFORMED NICKEL NOZZLE REFURBISHMENT

FNAS Investigation of Ultra-Smooth Surfaces

NAS8-38609

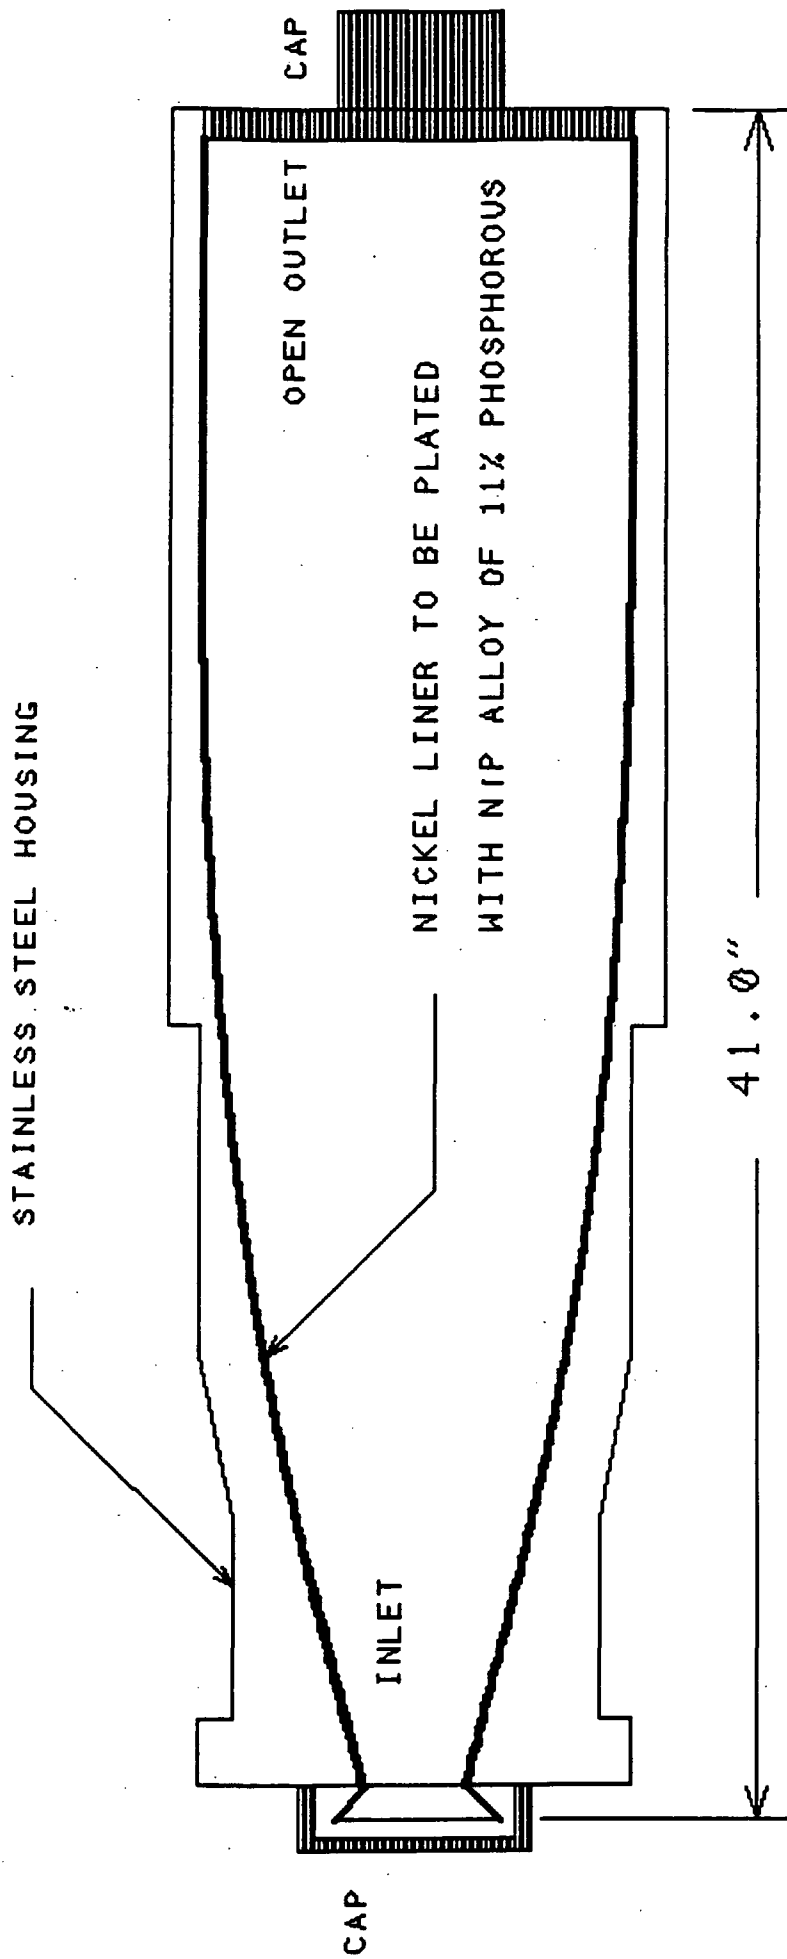
INLET HAS FRAGILE ROLLED LIP
WHICH MUST BE PRESERVED.
UNIT IS AXISYMMETRIC.
PLATING TO BE 0.0015 THICKNESS.
